Manhole Inspection Summary

Manhole # S35EE_033MH

Location Address: **4 BIDDLE ST**

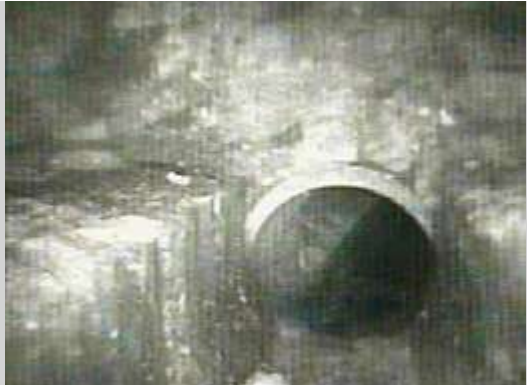
8 in. Circular Gravity Sewer Pipe Out @ 12 O'Clock

Rod and Bar (Angled)

Pipe Material: **Clay** ☐ Pipe Lined

Invert Depth: **11.42** (ft.) Flow Characteristics: **Fast**

Deposits: ☒ None ☐ Mud ☐ Sludge ☐ Debris ☐ Grease

Infiltration: **None** Pipe Seal Cond: **Unknown**

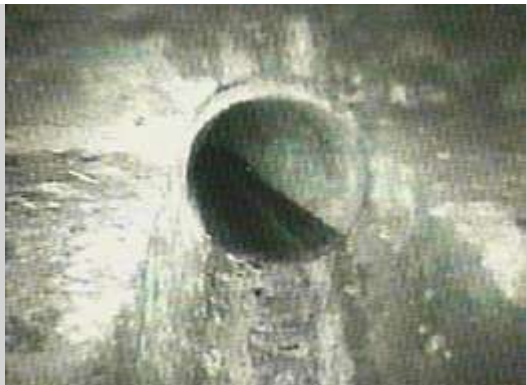
8 in. Circular Gravity Sewer Pipe In @ 6 O'Clock

Rod and Bar (Angled)

Pipe Material: **Clay** ☐ Pipe Lined

Infiltration: **None** Pipe Seal Cond: **Unknown**
